**SINT MAARTEN**

**EMERGENCY DEBRIS MANAGEMENT PROJECT  
(P167347)**

**Installation of a Temporary Weighbridge and Reconstruction of the Access  
road to the MSW Site  
Daily Management of the MSW Site Operations including  
Fire Suppression and Slope Recontouring**

**Environmental and Social Impact Assessment  
(ESIA)**

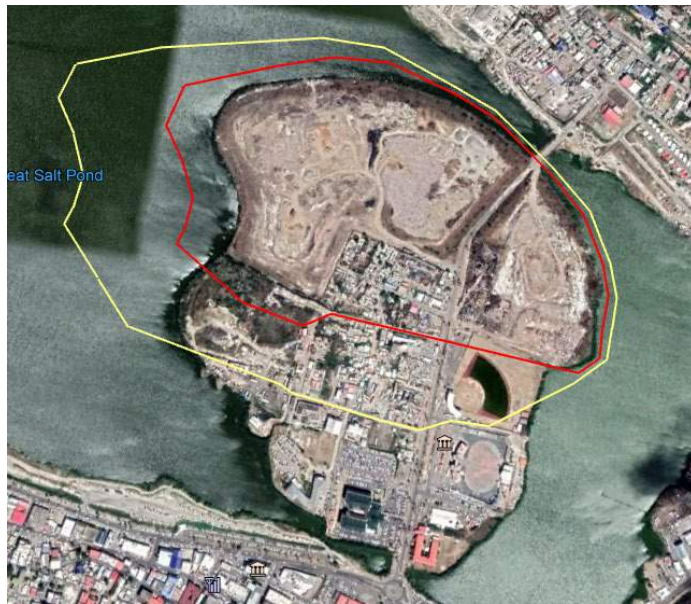
The Red and Yellow Zones were further adjusted for easterly prevailing wind directions, and designated as the Fire Suppression Exclusion Zone (red area) and the Caution Zone (yellow area), as shown in the Figure.

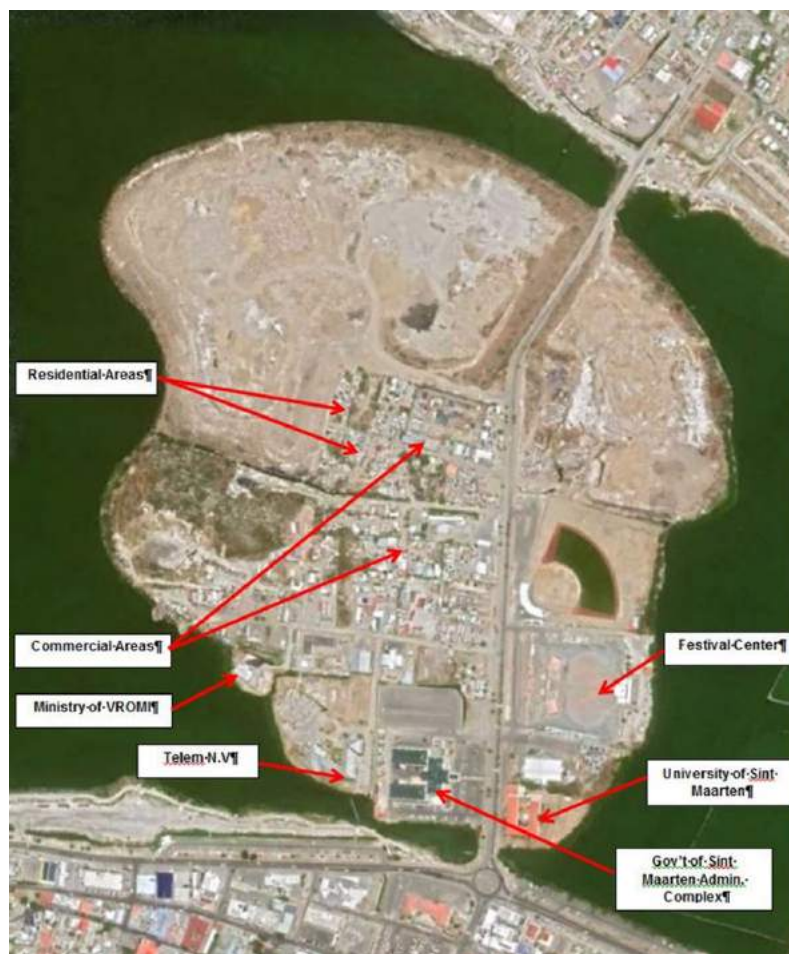
Figure 1.2 Aerial Photograph of Pond Island with MSW, and IDS Demographic Features

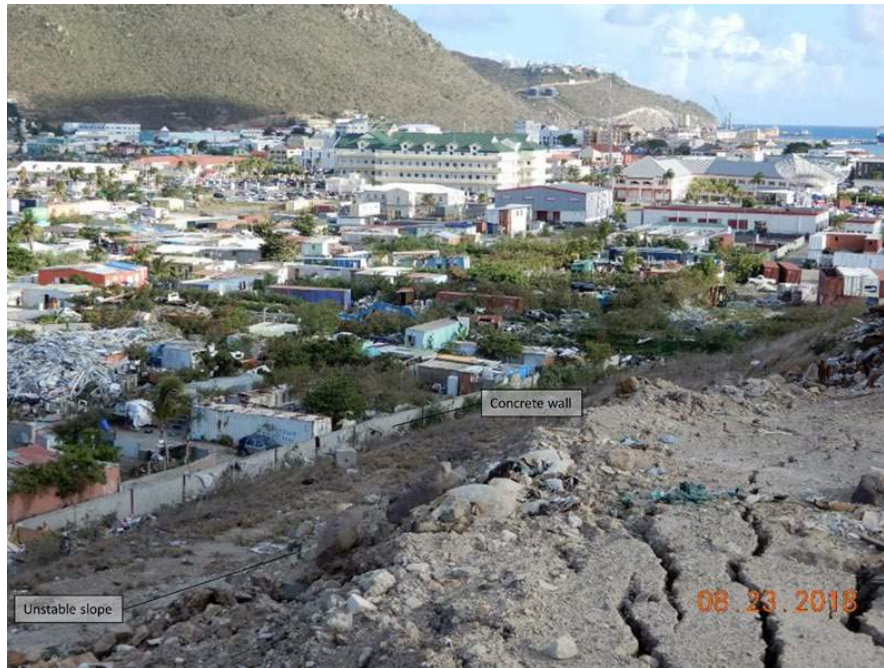
Figure 1.4 Unstable Slope Adjacent to a Populated Area as seen in 2018

In 2018, it was observed that some of the side slopes of the MSW landfill were too steep, with slopes approaching 1:1 and potentially unstable (A typical landfill side slope is graded at a slope of 3 meters horizontal (3H) to 1 meter vertical (1V). This is represented by the term 3:1.). In addition, continuous subsurface fires had caused cracks or fissures to form on the surfaces of the MSW landfill, which in turn can be related to subsurface instability. The proximity of a potentially unstable slope to the adjacent residential and commercial area is evident in Figure 1.4.

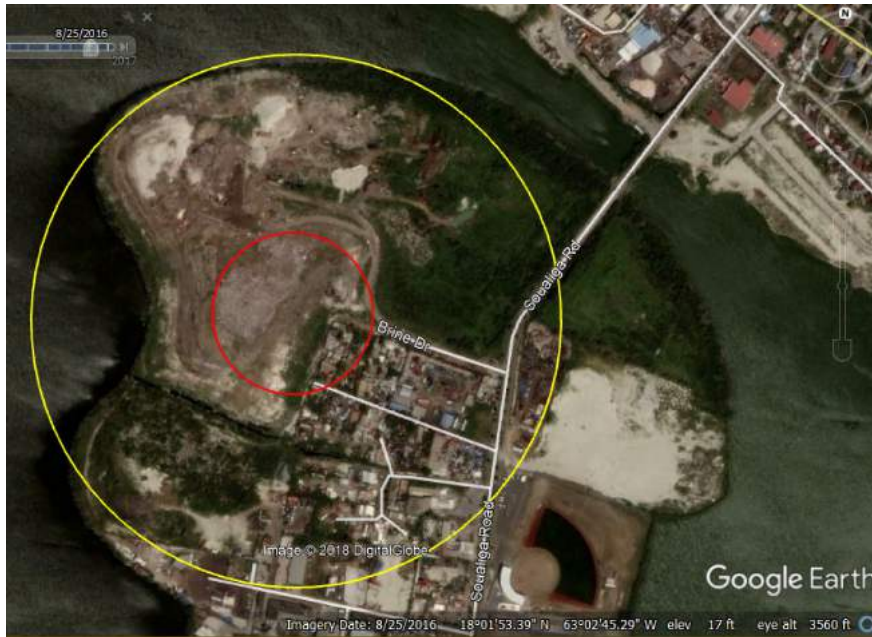
Figure 1.6 Red and Yellow Zones Identified in Threat Zone Document

In August 2018, an assessment on fires and structural conditions of the MSW/IDS Sites was performed. Based on that assessment, a preliminary “Red Zone” and “Yellow Zone” of safety was designated: Red Zone at 300 ft, and Yellow Zone at 1000 ft. These zones were based off safety procedures used for landfill firefighting, slope stability at the MSW Site and the prevailing wind directions across Sint Maarten these zones are shown in Figure 1.6.

The Yellow Zone was described as a “notification zone”, whereby businesses and residences would be notified of the fire suppression activities and be prepared to evacuate if necessary.

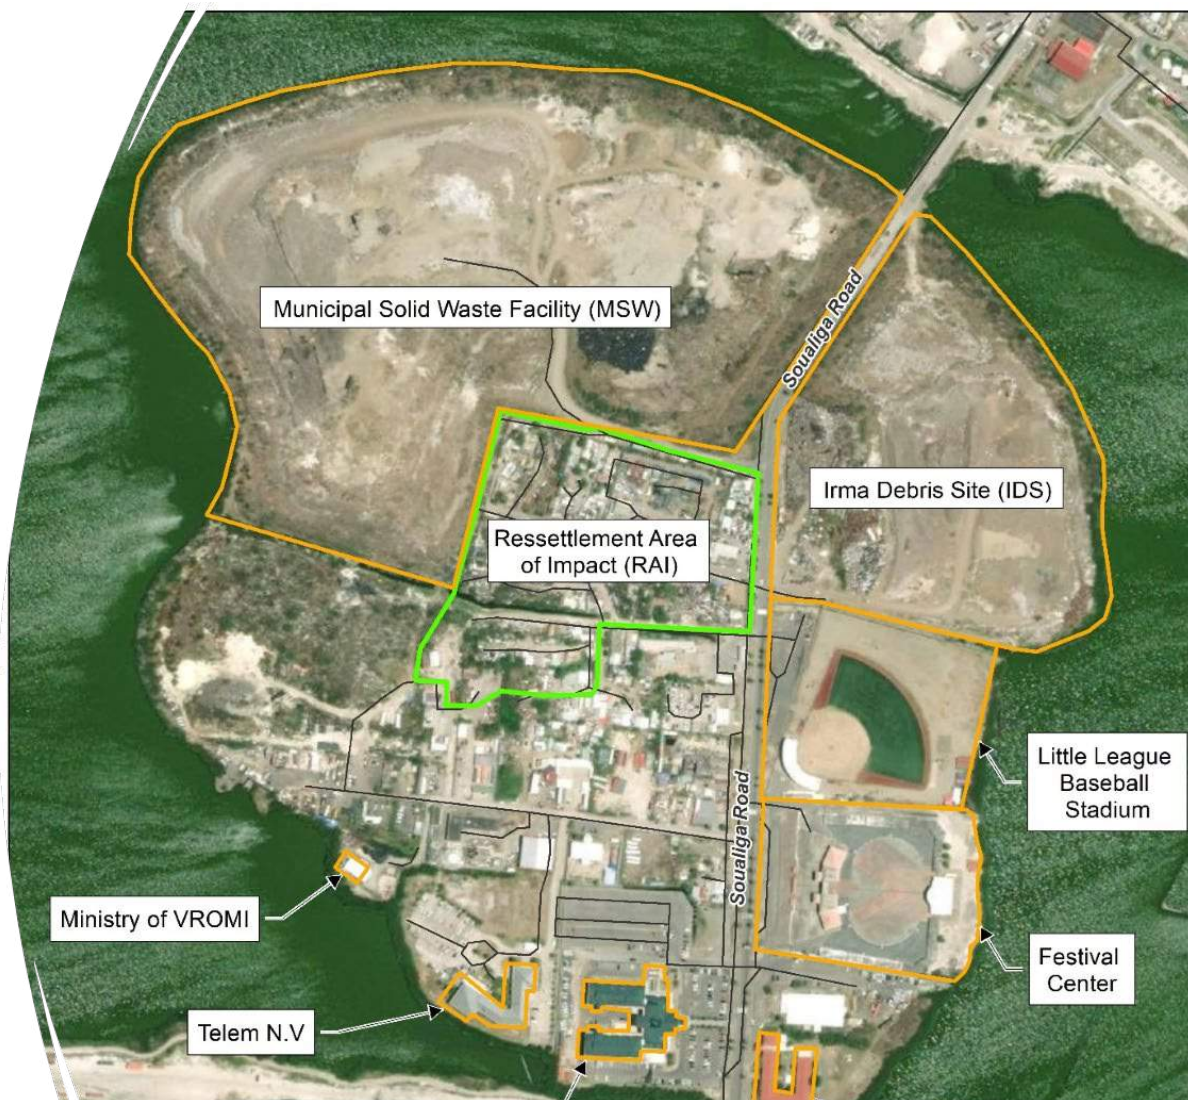
Figure 1.7 Resettlement Area of Impact and surrounding

Continued assessment of the situation resulted in the identification of the RAI, which besides the Blue Box zone also included a corner within a 100 meter radius of the tip of the south-east slope at the MSW. This is depicted in figure 1.7, below.

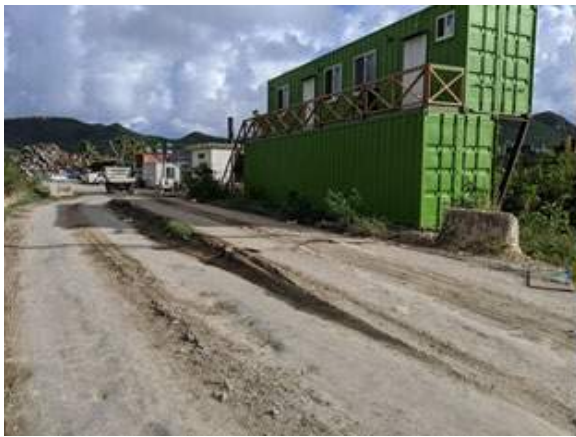
large trucks. The nominal capacity of the weighbridge scale must be 45 metric tons. Works will include the installation of the electrical infrastructure suitable for the connection of the scale to power source and for reconditioning the existing metal container facilities as the scale operating office. The following figures 1.8 & 1.9 show the future location of the new weighbridge scale, existing scale house and the trace of the access road at the MSW landfill, which will be paved.

*Figure 1.8 shows the existing security and scale house and old weighbridge scale location and future location of new weighbridge scale and the trace of the access road that will be reconstructed.*

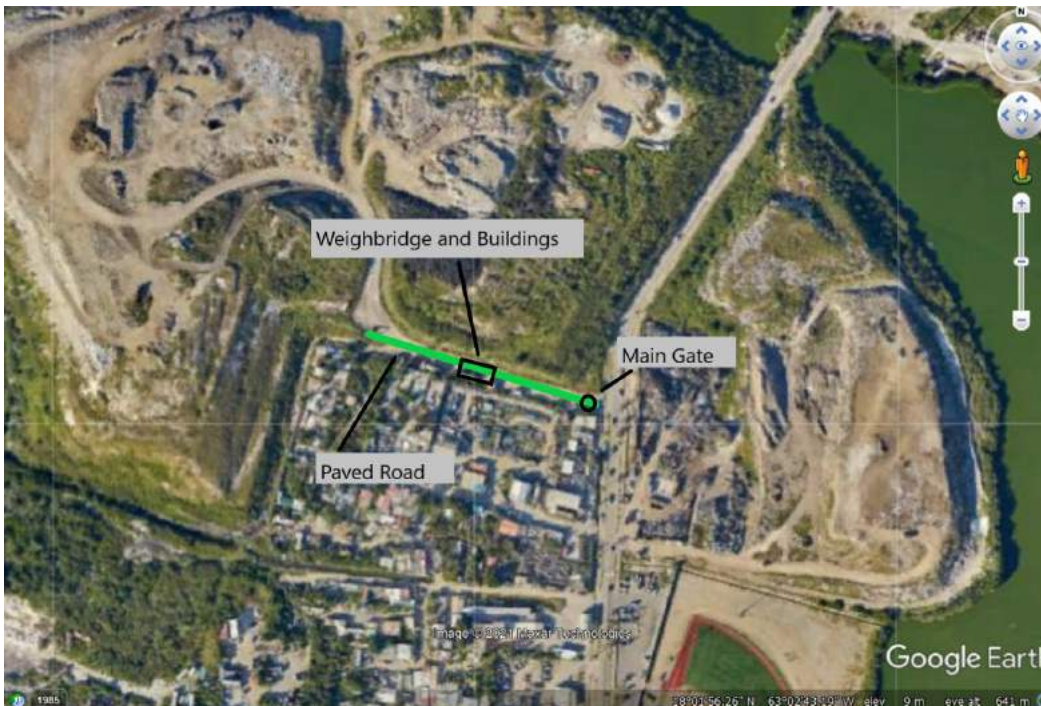
*Figure 1.9 show details of the location of works related to the paving of the existing access road (Brine Drive) to the MSW landfill, the placement of a main gate, weighbridge scale and buildings.*

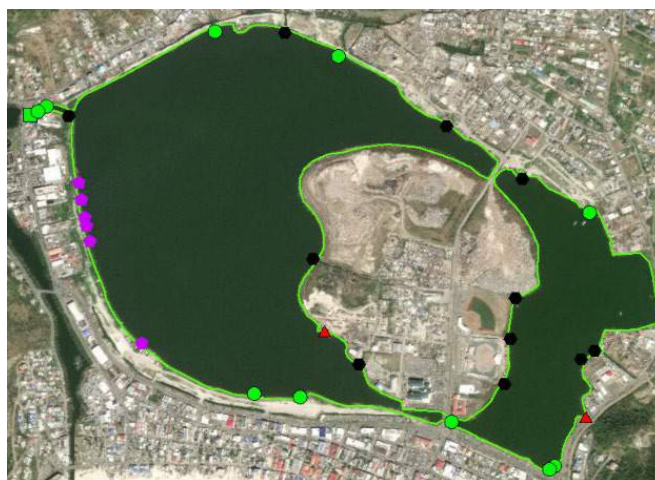
Figure 3.2 – Great Salt Pond Inflow/Outflow Summary, 2019

Great Salt Pond accepts stormwater runoff from the MSW/IDS landfills as well as the surrounding areas, numerous inflow/outflow points were identified where water can intermingle with adjacent bodies of water. A copy of the inflow/outflow assessment of the Great Salt Pond is presented below in Figure 3.2

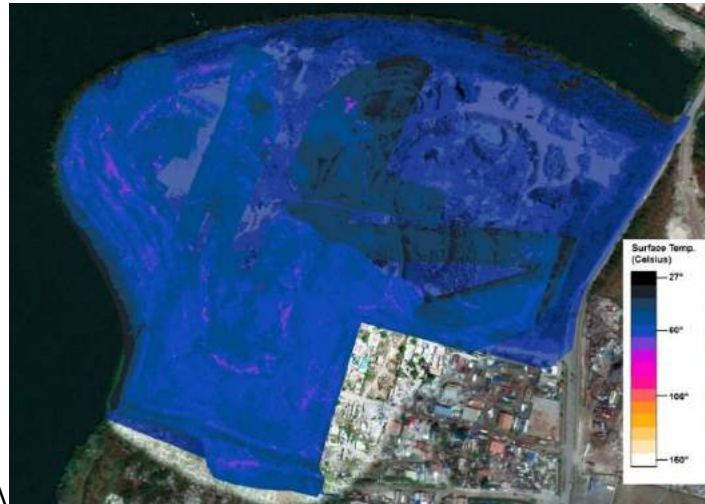
Figure 3.6 June 2018 Aerial Infrared Thermal Survey of MSW Site

An aerial thermal infrared survey conducted in June 2018 using an Unmanned Aerial Vehicle (UAV) and a high resolution FLIR thermal sensor visual camera captured elevated surface temperature and identified the locations of hot spots and potential subsurface fires (see Figure 3.6). The exact location of several hot spots and vents were identified using infrared thermography from ground level (see Figure 3.7).

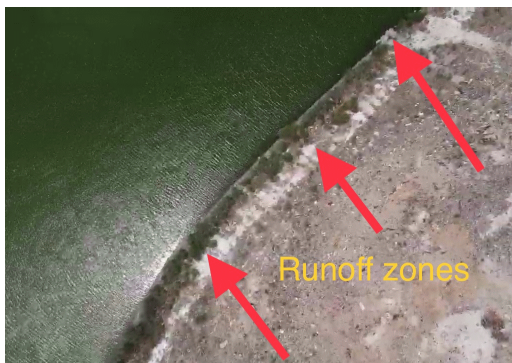
Figure 3.9 Runoff zones at MSW Site to Great Salt Pond

- MSW – A drainage ditch located to the south of the MSW was observed that discharged to the Great Salt Pond and multiple locations of runoff into the pond were observed, there was evidence of trenching and what appeared to be a leachate management system along the perimeter. The below photos show locations of the runoff location.

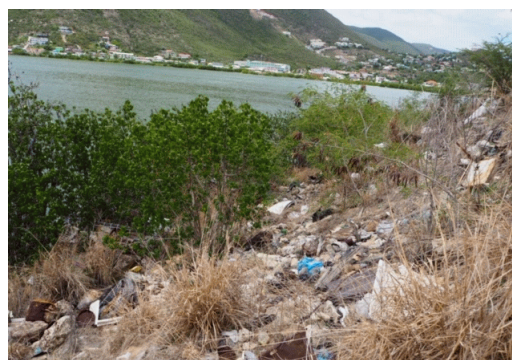
Figure 3.10 Runoff Zone and drainage canal to Great Salt Pond

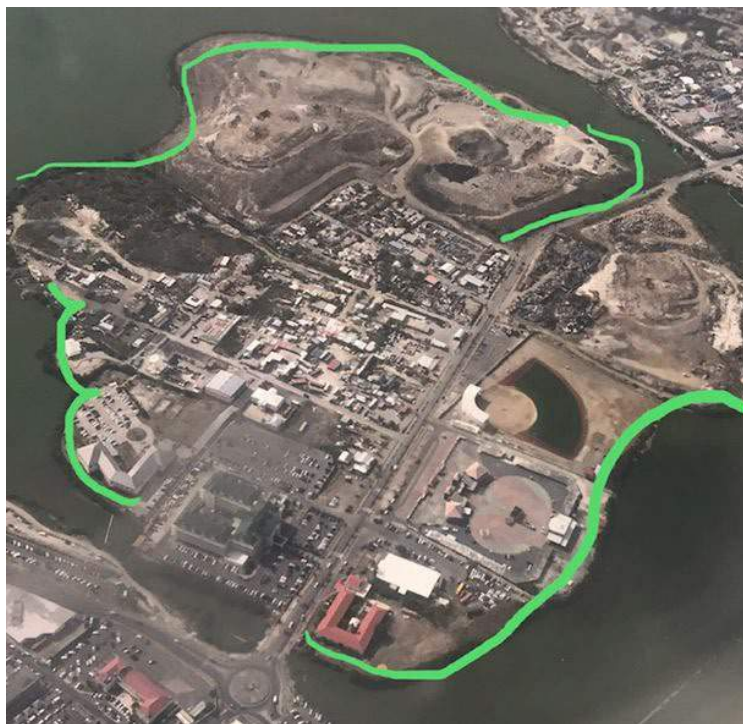
Figure 3.11 - Mangrove Thickets Surrounding Pond Island (Shown in Green)

Around the Great Salt Pond four species of mangroves can be found; *Rhizophora mangle* (Red Mangrove), *Avicennia germinans* (Black Mangrove), *Laguncularia racemosa* (White Mangrove) and *Conocarpus erectus* (Buttonwood). See Table 3.2 for typical mangrove zonation and characteristics and Figure 3.11 for mangrove thicket locations around Pond Island.

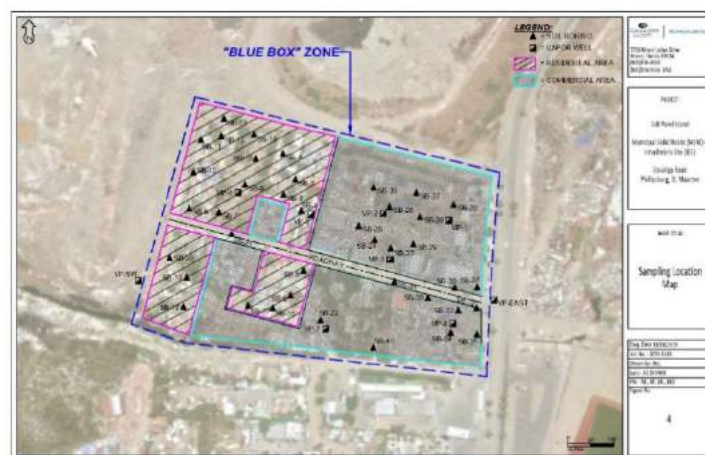
Figure 3.14 Soil Sampling Locations

The surface soil and vapor assessment was conducted within the “Blue Box” zone in Pond Island MWS/IDS (see Figure 3.14 below). The “Blue Box” zone was identified by GBTS as an area of probable PAP relocation. The scope of the preliminary surface soil and vapor assessment was prepared to meet the following objectives:

- LFG sampling – a total of 9 vapor wells were installed
- Soil sampling - Forty (40) soil samples were collected from a depth of 0 to 6 inches below the surface. This was considered to be the layer of soils that the public potentially could have contact with on a daily basis during normal activities. Two background soil samples also were collected in areas that were judged to represent the original fill material in the area (pre-MSW). These samples were collected from approximately 2 to 3 feet below land surface.

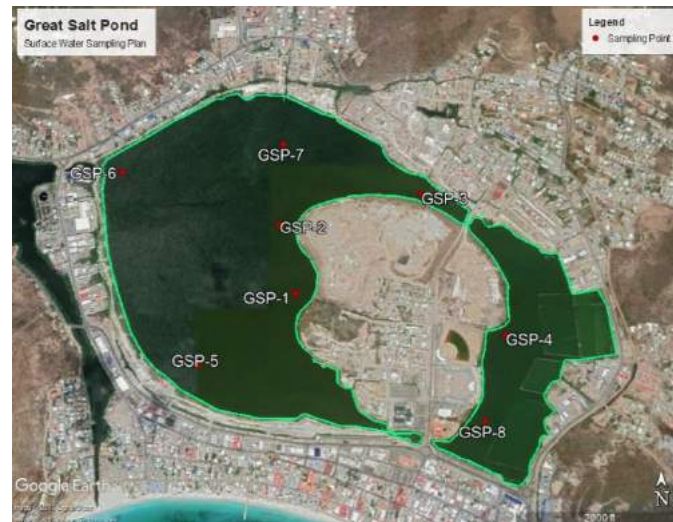
Figure 3.15 Surface Water Sampling Locations

parameters and representative water samples were collected from both the surface and the bottom of the water column. Of the 8 discrete sampling locations, 5 were located in the western portion of the Great Salt Pond and 3 background locations were located in Great Salt Pond. See Figure 3.15 for a map depicting the discrete sampling locations.

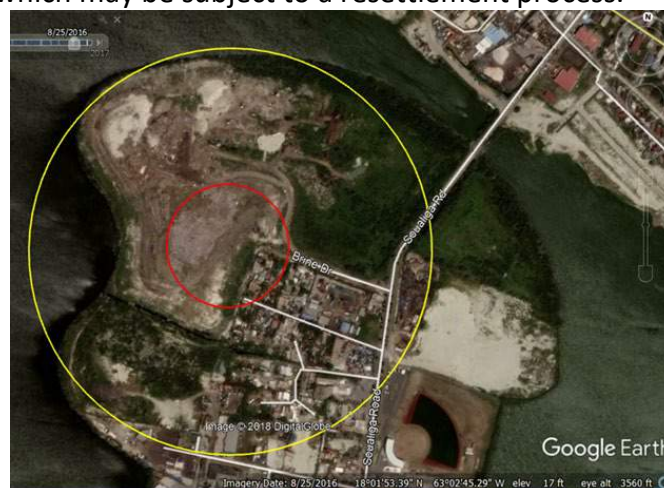
Figure 3.16 Yellow Zone Boundaries in the Terms of Reference for the Social Baseline Study

The consulting firm RINA was contracted by the NRPB to conduct a MSW/IDS Sites neighboring communities census, (see annex H, RINA Socioeconomic survey of the Yellow Zone 2019), to be used as the social baseline and structuring the framework for the Resettlement Action Plan (RAP) for the population located in the area near the MSW/IDS Sites in the area defined as the Yellow Zone (figure 3.16). The Yellow zone is defined as a “notification zone” which may be subject to a resettlement process.

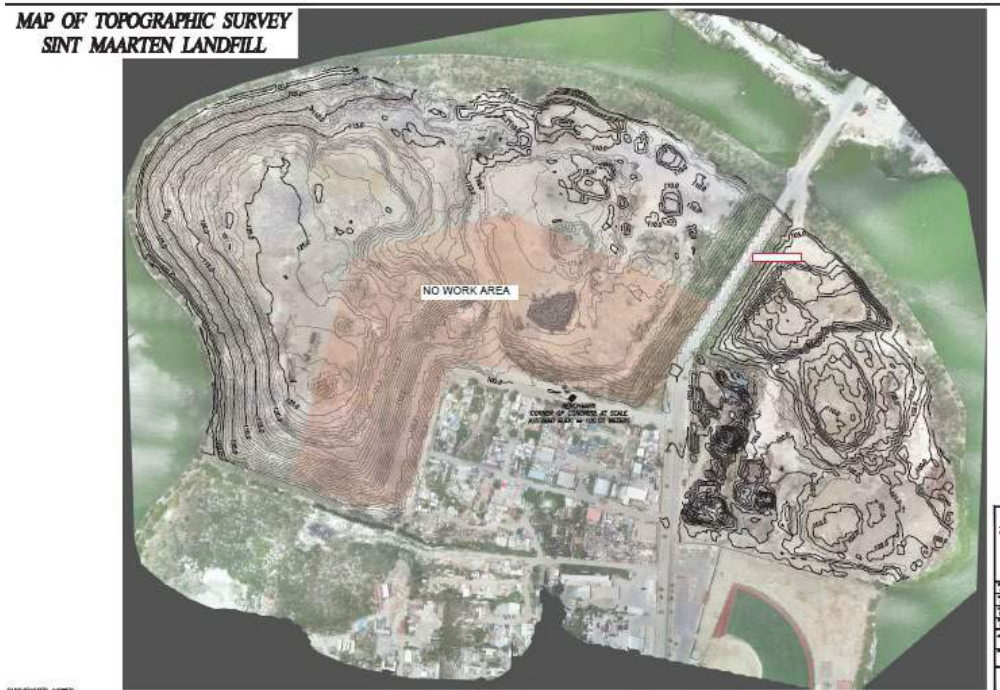
Figure 3.17 No Work Zone, as recommended by SCS Engineers April 22, 2020

C, and figure 3.17 bellow, and states: “...Based on the limited data available, SCS has estimated an area of concern where there should not be any recontouring efforts until additional investigations have been conducted or relocation of residents has been completed. Activities that should not be conducted include excavation of waste, placement of relocated waste, fire suppression that involves injection of water/grout, and placement of new waste (to name a few). The attached figures show the recommended area of concern and “No Work” zone.”

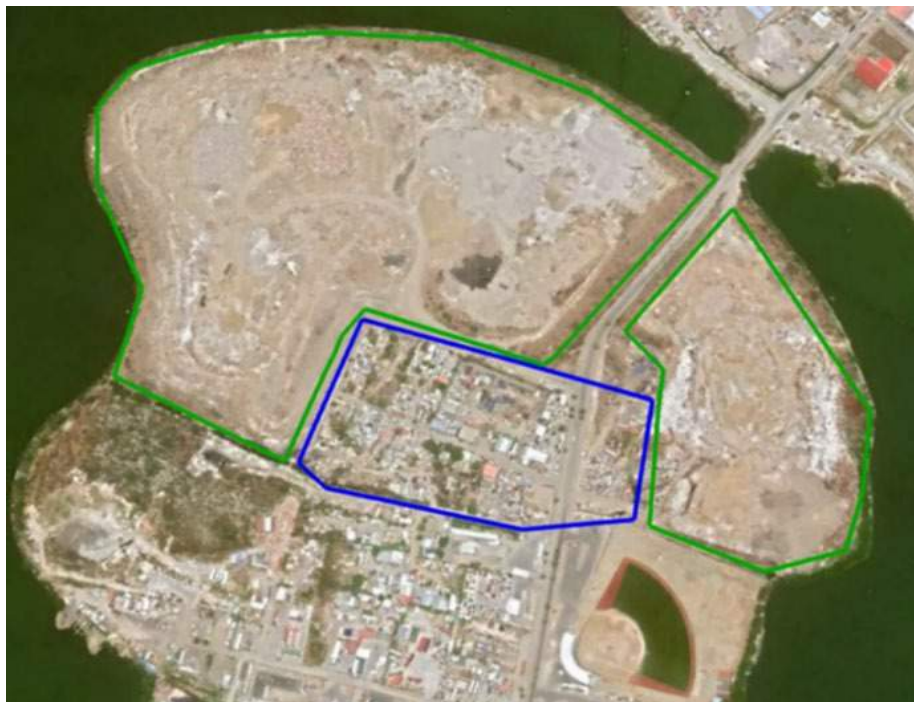
*Figure 3.18 The Blue Box Zone*

A smaller portion of the Yellow Zone was identified as an area where resettlement would be required; this area was designated as the Blue Box Zone and a later in the process the Resettlement Area of Impact.

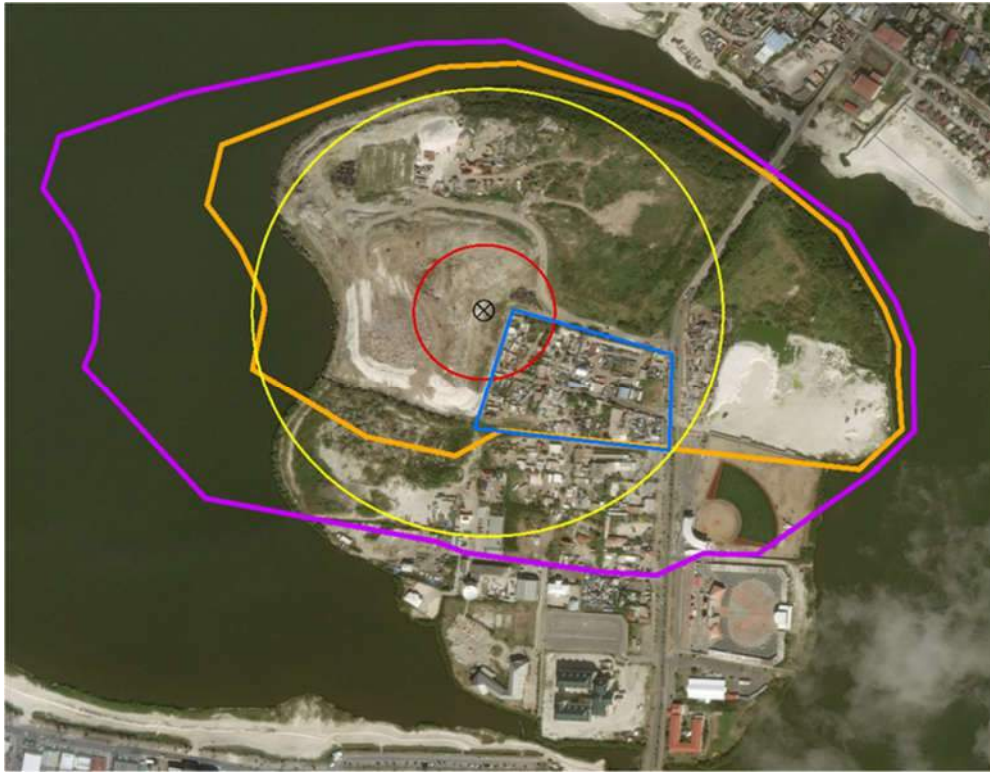
Figure 1 – Red Zone, Yellow Zone and Blue Box Area

- Background document which indicated that the slope and presence of cracks/fissures along the southeast portion of the MSW presented a hazard to the adjacent community.
- Threat Zone document prepared by Hammer Consulting dated July 2018, which indicated that the community immediately adjacent to the southeast corner of the MSW were in immediate danger and should be evacuated. This created the concept of the Red and Yellow Zones. The Red Zone was an area that should be evacuated prior to the commencement of works to address the slope and/or fires, and the Yellow Zone, which was an area where the community would be notified of the hazard and may need to be evacuated if conditions deteriorated. The Red and Yellow Zones are shown in Figure 1.

- Position statement prepared by EE&G in June 2019, documenting the need for consideration of relocating an expanded portion of the community adjacent to the MSW, since it was downwind or crosswind of areas known to have surface or subsurface fires. This resulted in an expansion of the areas where temporary relocation should be performed during the Fire Suppression Activity, which was termed the Blue Box Area (Figure 1).

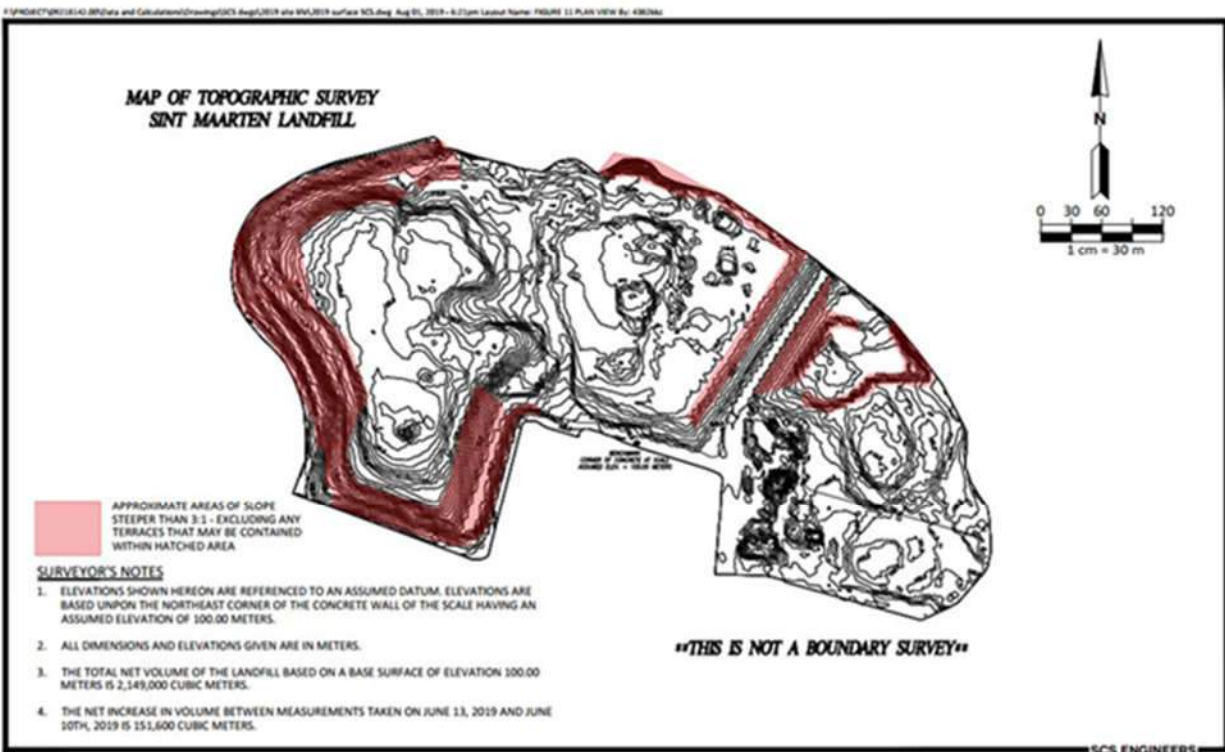
Figure 4 - 2019 Topographic Map Showing Areas with Slope Greater than 3:1

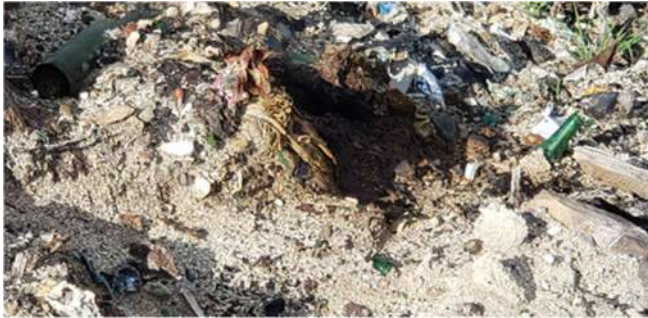
Figure 6 - Hot Spot on Northwest of MSW

Other than the two locations mentioned above, the scanning of the surfaces of the Landfill Sites using the infrared camera did not show thermal 'Hot Spots' that suggested venting or presence of subsurface fires. Figures 6 through 9 show representative photos observed on the northwest and southeast portions of the MSW.

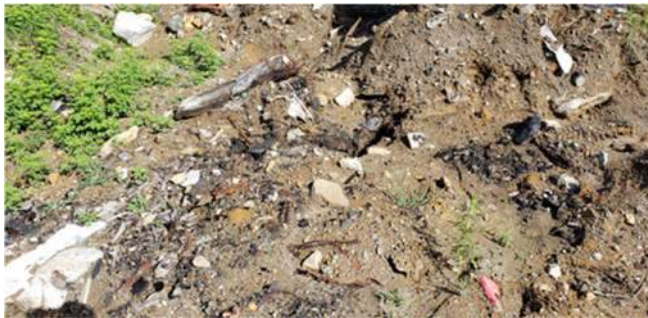
Figure 8 - Hot Spot on Southeast of MSW

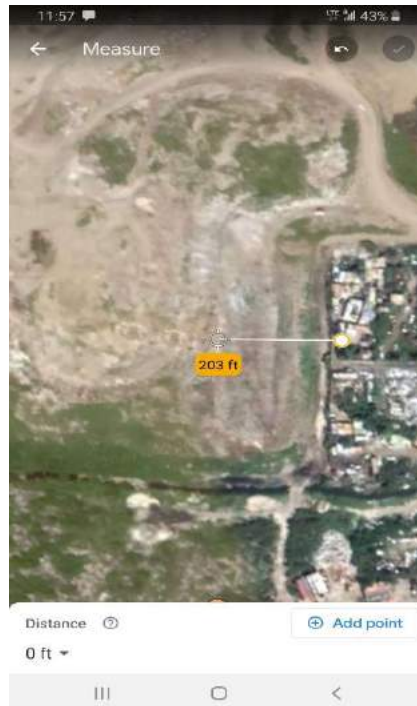
Figure 12 - Location of Southeast Hot Spot Relative to Community

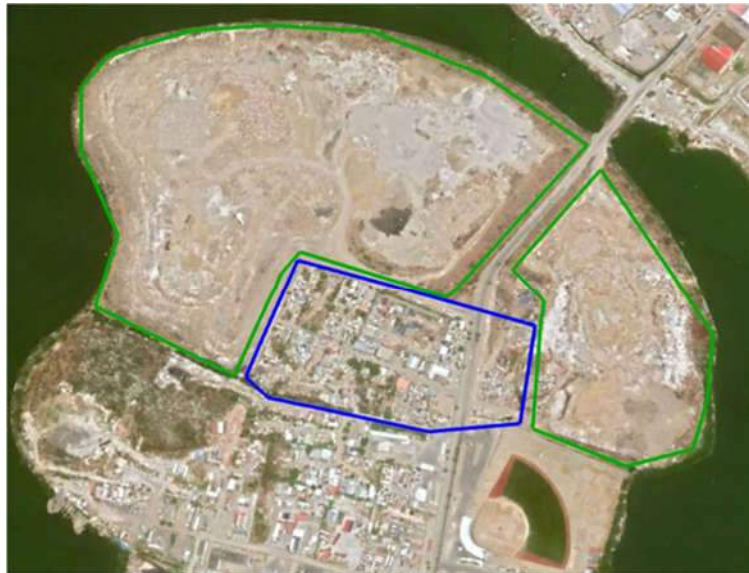
Figure 13 - Blue Box Area

- Assessment of fires must remain an ongoing task. The conditions that were observed on Monday January 27, 2020 should not be considered the Final Condition by which all future plans are determined. The nature of subsurface smoldering wastes is such that new fires could start with the addition of air at any time. It is recommended that a formal Fire Monitoring Program be developed and implemented whereby a weekly assessment is performed with the proper equipment to routinely verify and document the location of any fires or signs of combustion, so that appropriate action can be taken.
- Absent subsurface fires, civil works may be performed in some locations of the Landfill Sites, in a manner that is protective of human health & environment without relocation of the Blue Box Area (Figure 13)

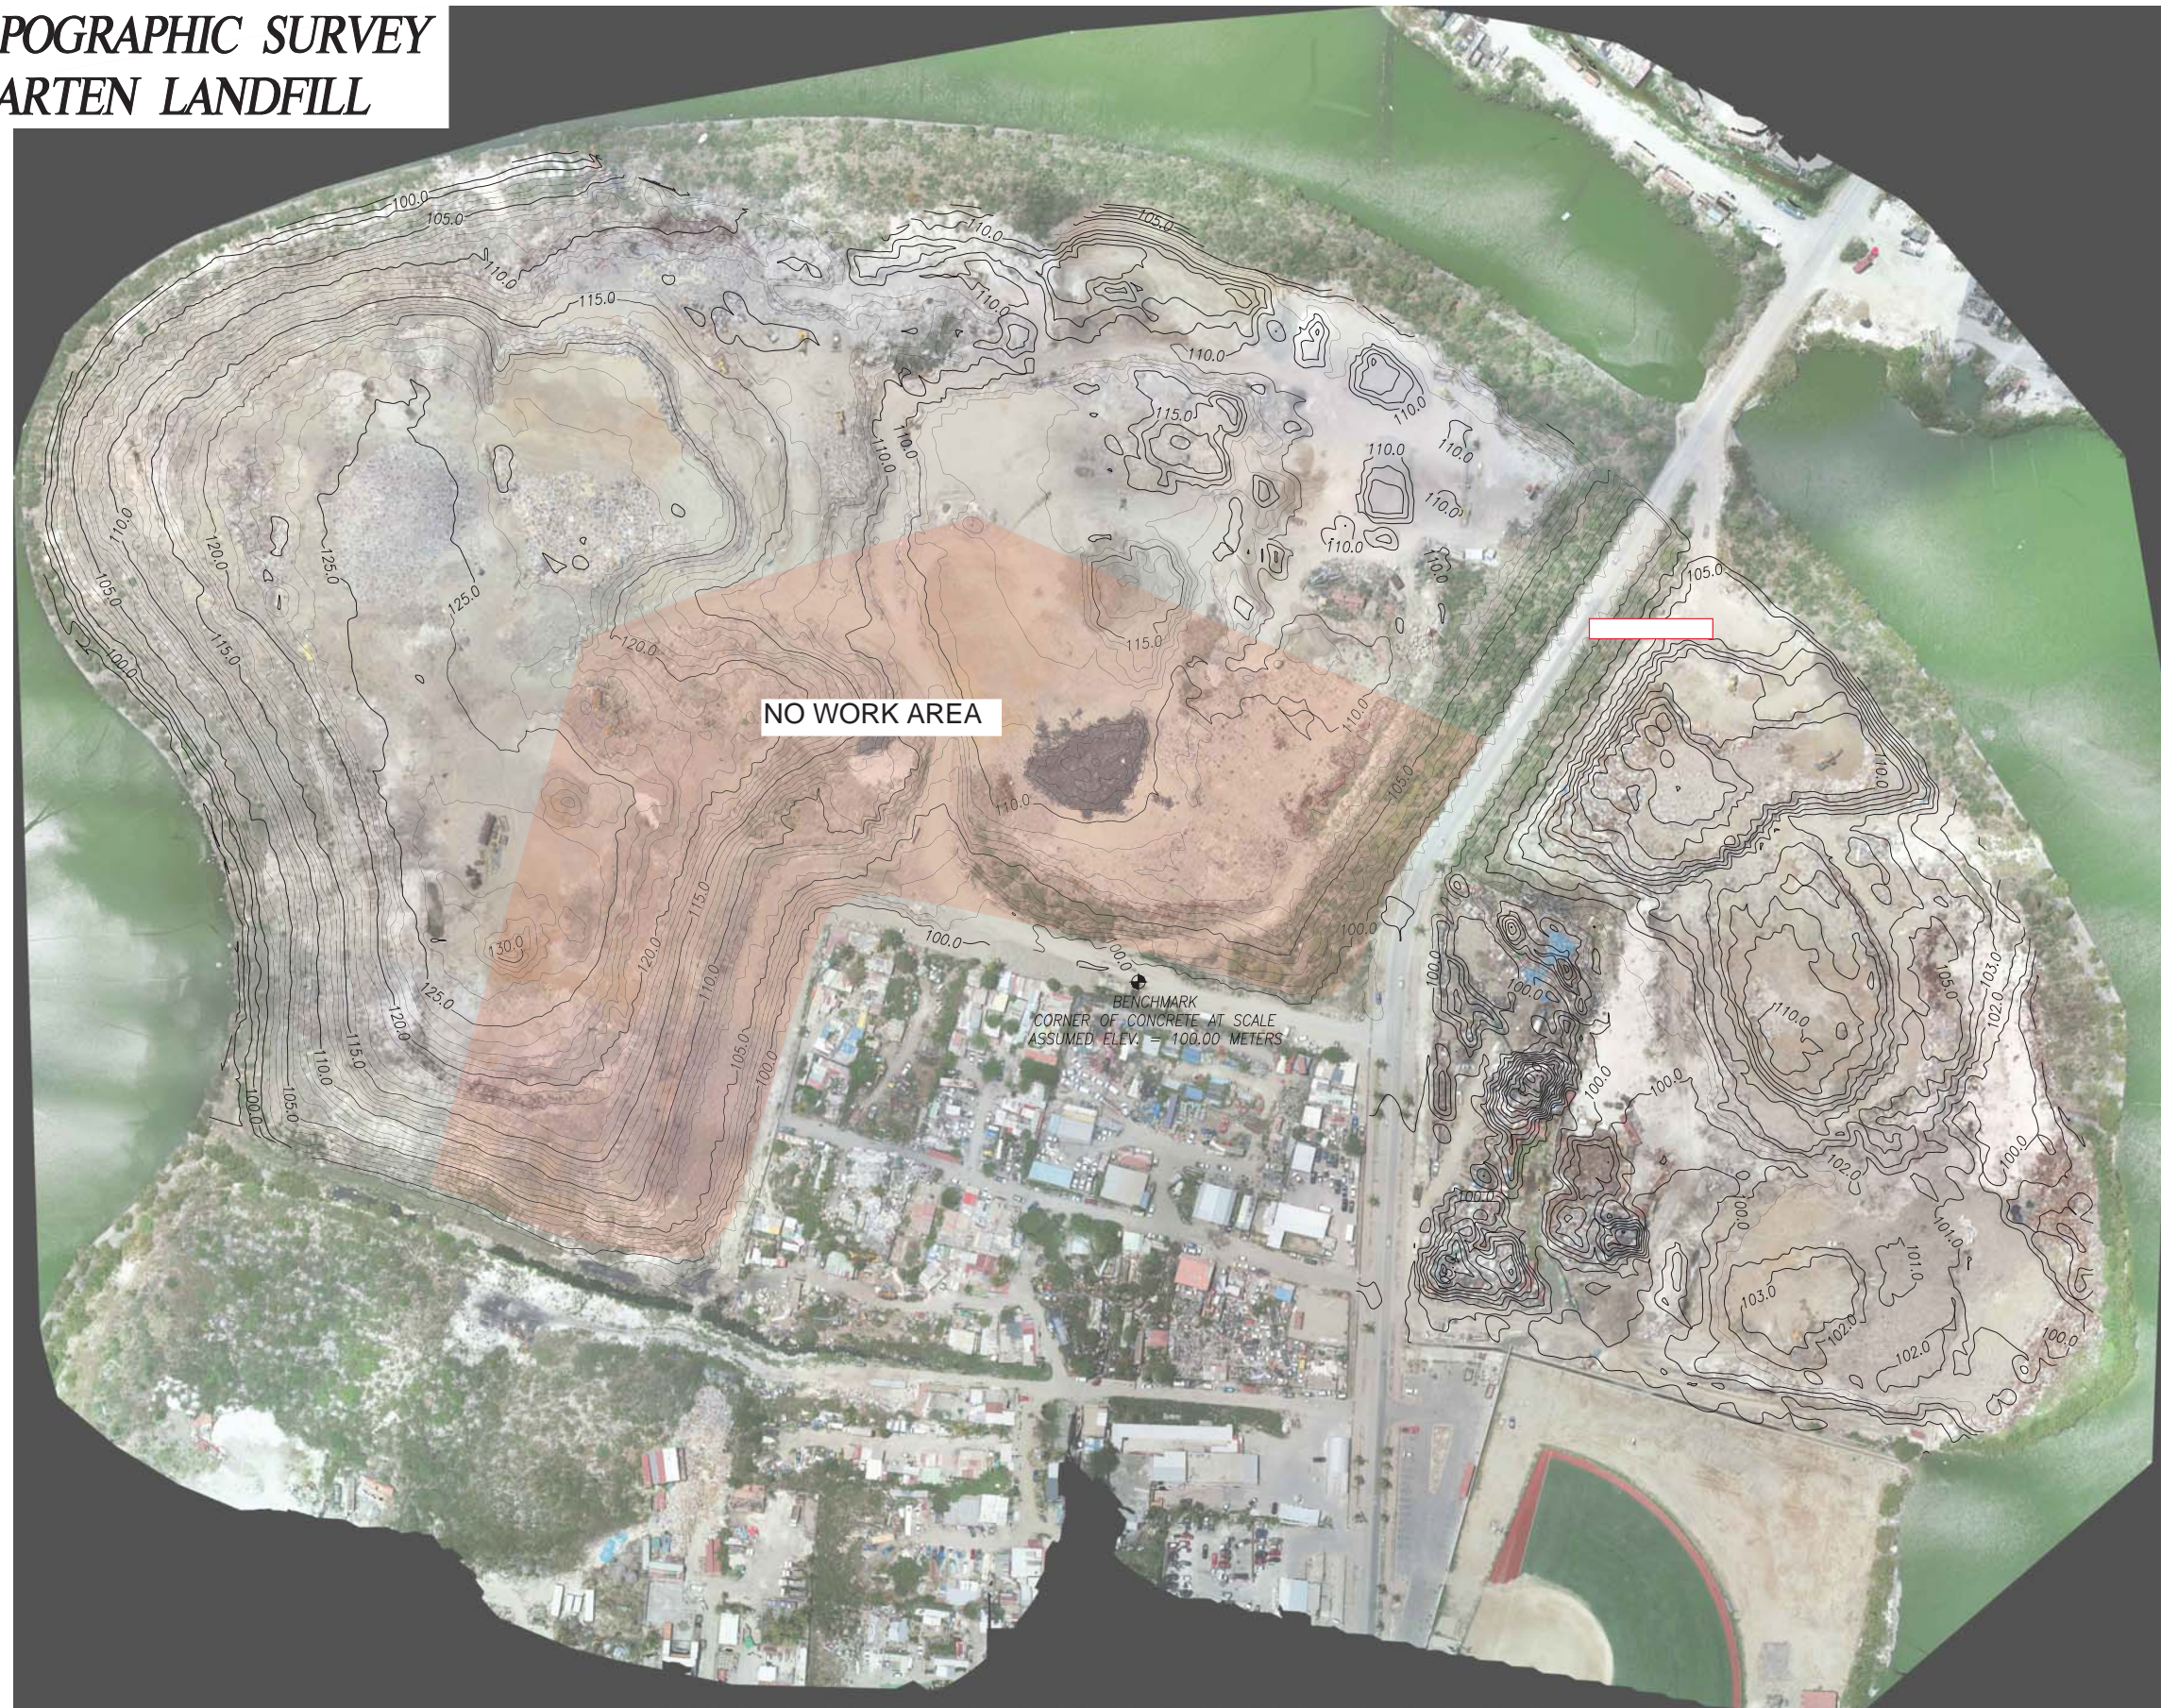
# MAP OF TOPOGRAPHIC SURVEY SINT MAARTEN LANDFILL

**NO WORK AREA**

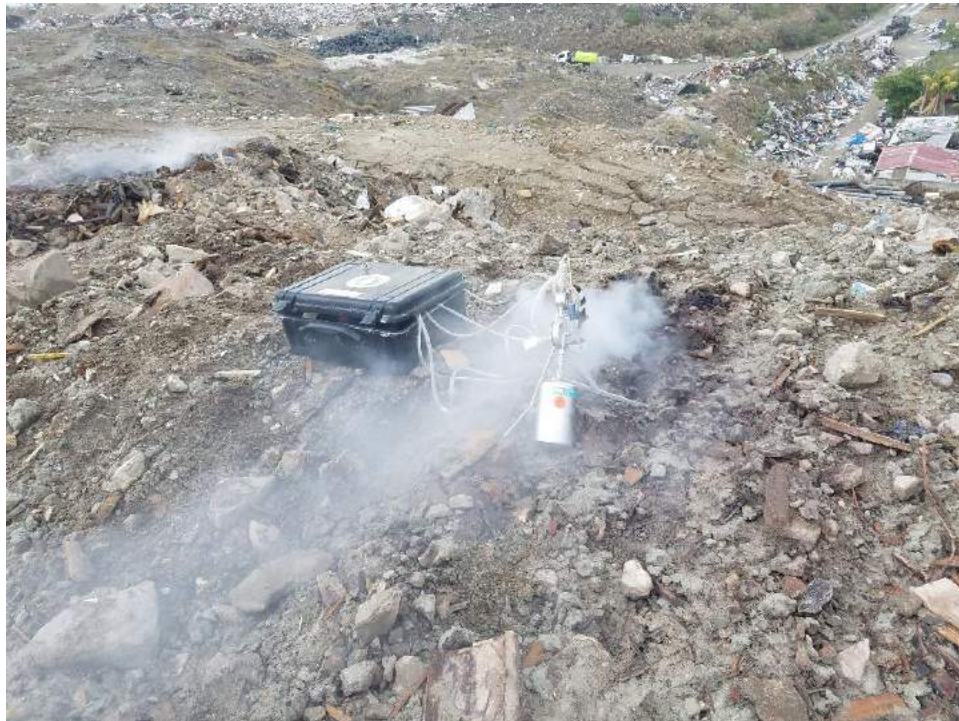
**Photo 1 – Typical Area Sampling Station Placement**

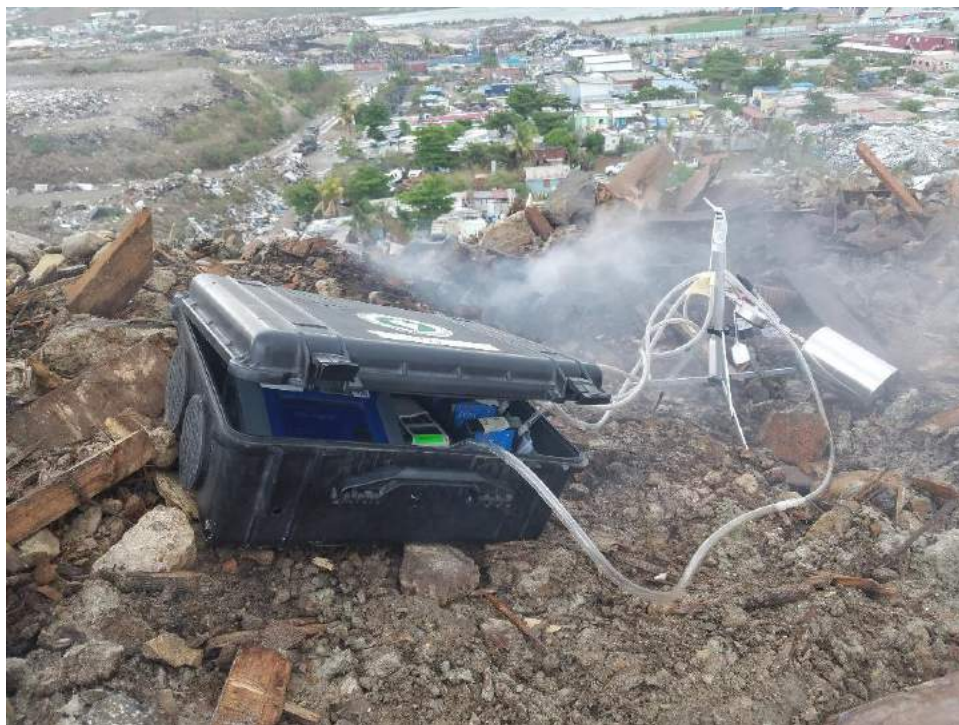
**Photo 2 – Typical Area Sampling Station Placement**

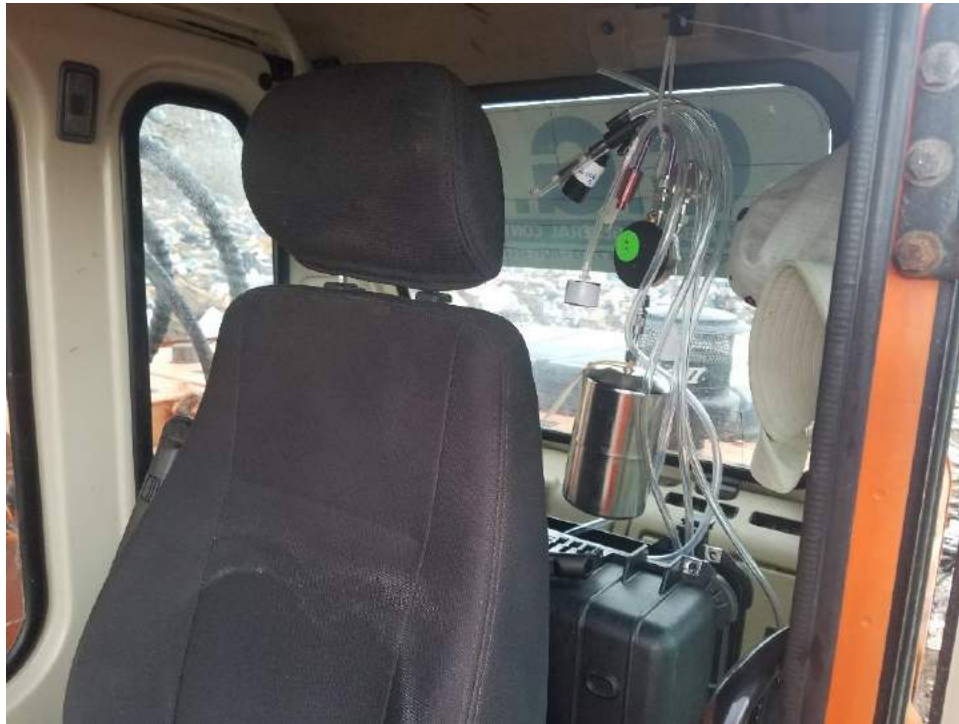
**Photo 3 – Typical Personnel Sample Placement**

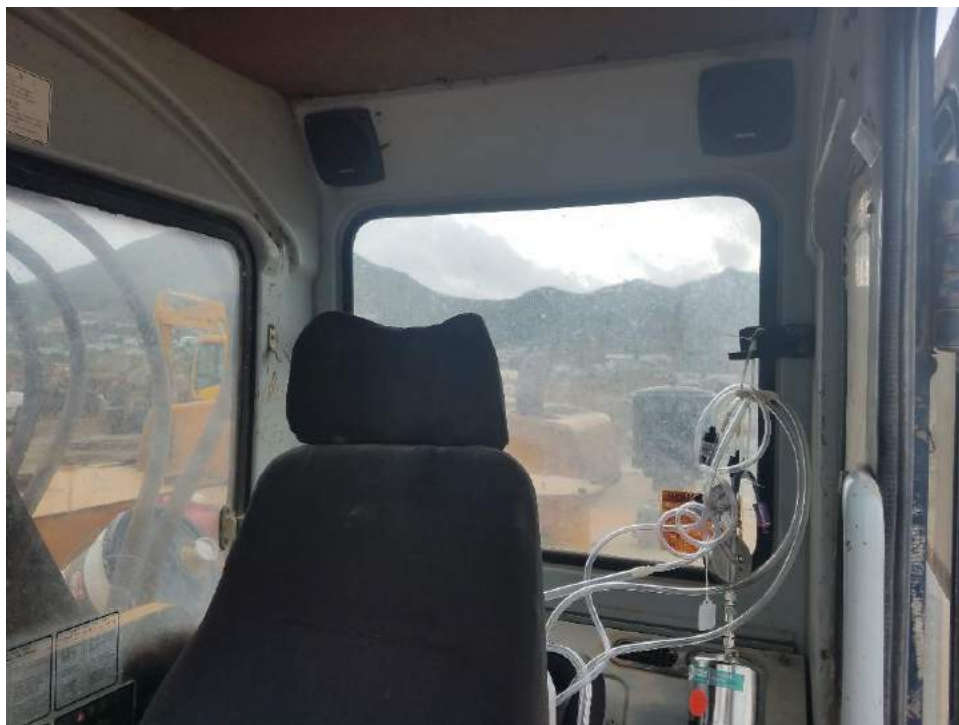
**Photo 4 - Typical Personnel Sample Placement**

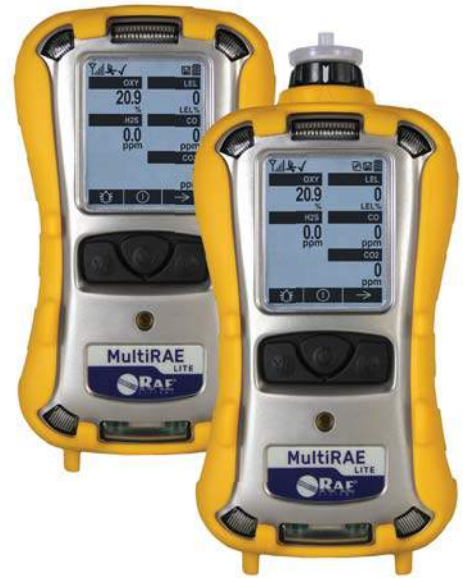
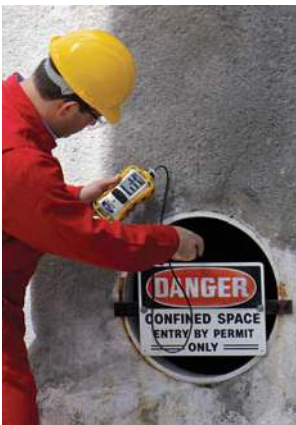
Confined space testing with the MultiRAE Lite

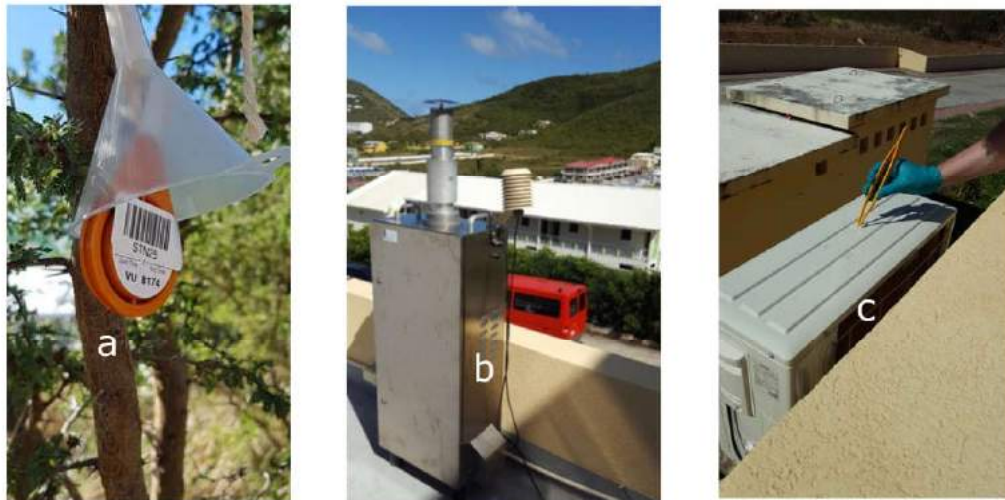
Figure 1. 3M badge for passive sampling at location 1 (a), Leckel filter equipment at location D (b) and swiping dust for historical interpretation (c).

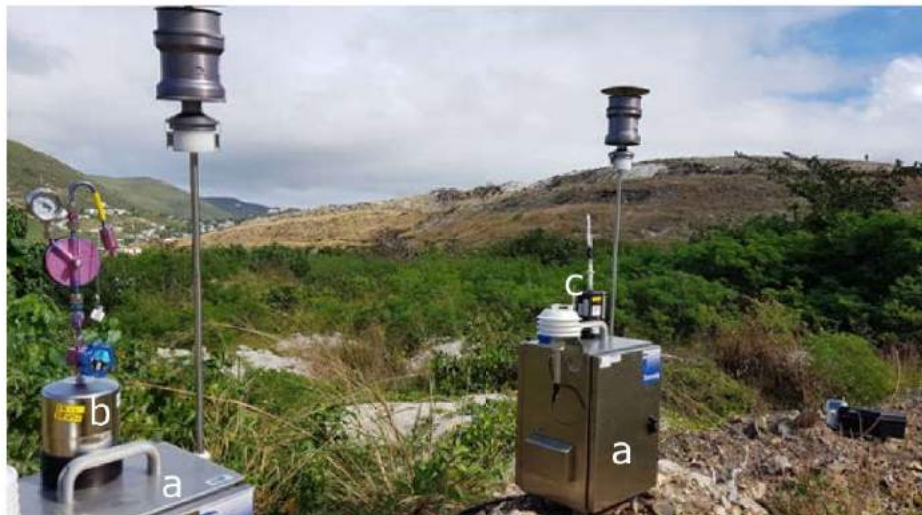
Figure 2. Two KFG dust samplers (a), canister (b) and pump with sorbent tube (c) at VROMI yard (location 4).

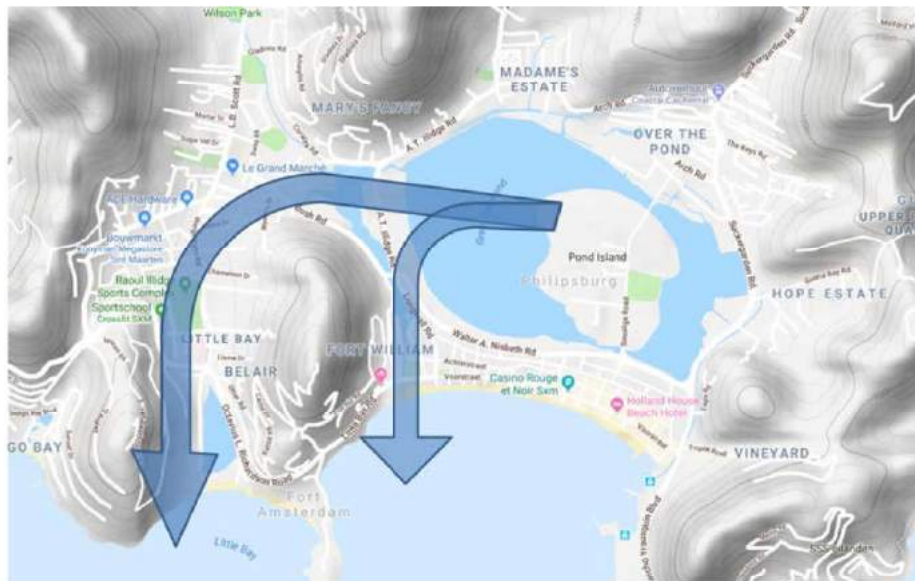
Figure 3 Local airflow under easterly wind conditions
