**SINT MAARTEN**

**EMERGENCY DEBRIS MANAGEMENT PROJECT  
(P167347)**

**Installation of a Temporary Weighbridge and Reconstruction of the Access  
road to the MSW Site  
Daily Management of the MSW Site Operations including  
Fire Suppression and Slope Recontouring**

**Environmental and Social Impact Assessment  
(ESIA)**

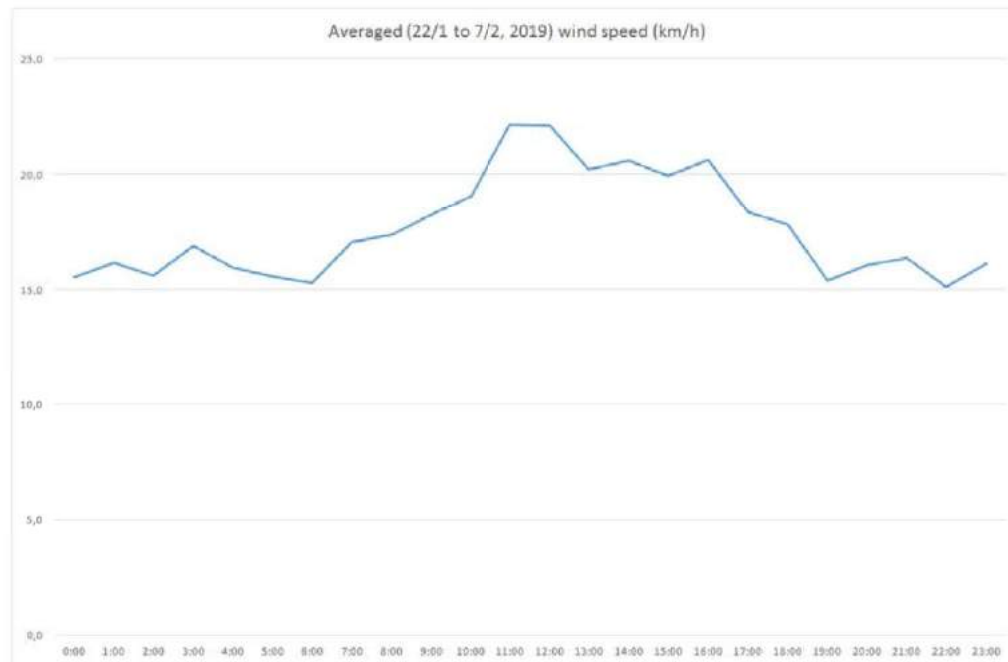
Figure 4 Averaged wind speed during the day for the period of 22<sup>th</sup> January to 7<sup>th</sup> February 2019.

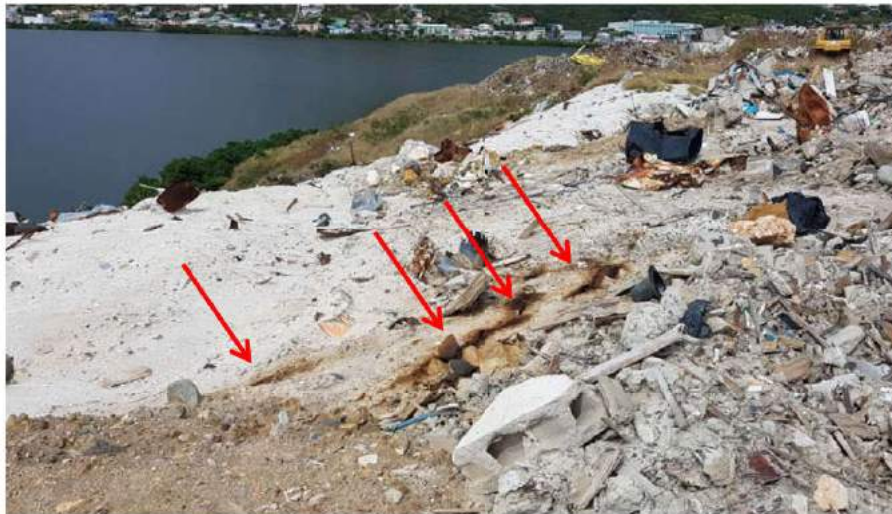
Figure 6 Smoke holes (brown/black spots marked by a red arrow) from smouldering fires inside the landfill.

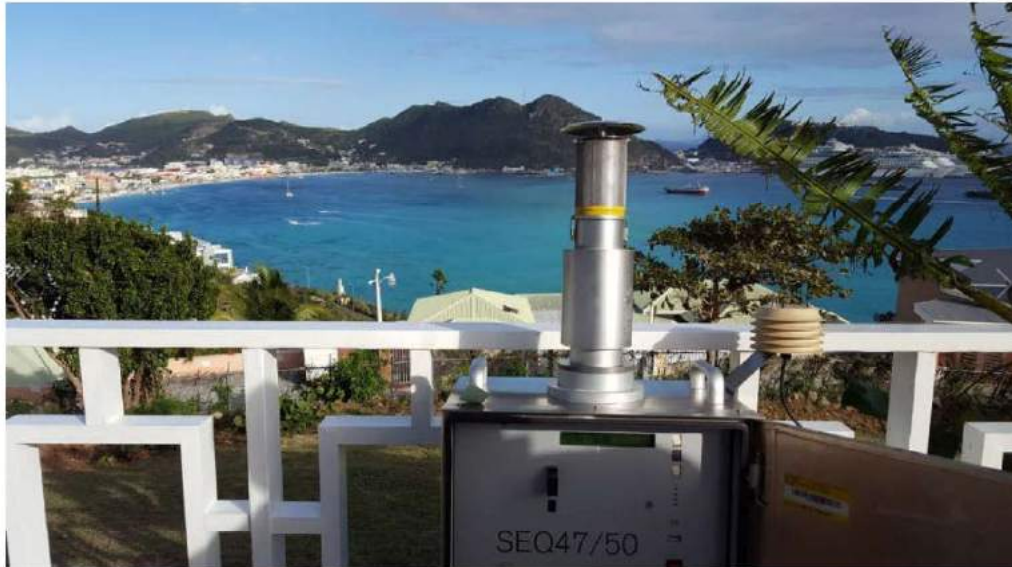
Figure 7 Leckel 24/7 dust sampler at Belair (location C)

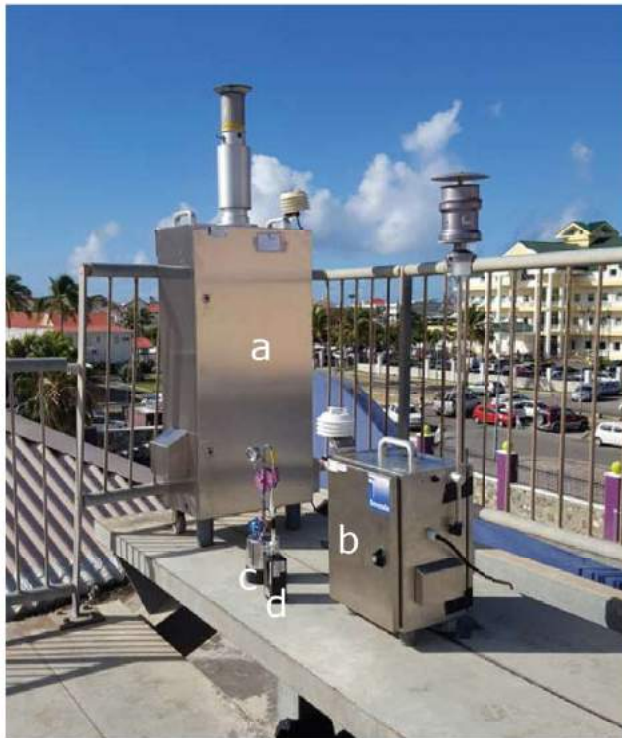
Figure 8 Leckel 24/7 dust sampler (a), KFG dust sampler (b), canister (c) and pump with sorbent tube (d) at the festival terrain (location A)

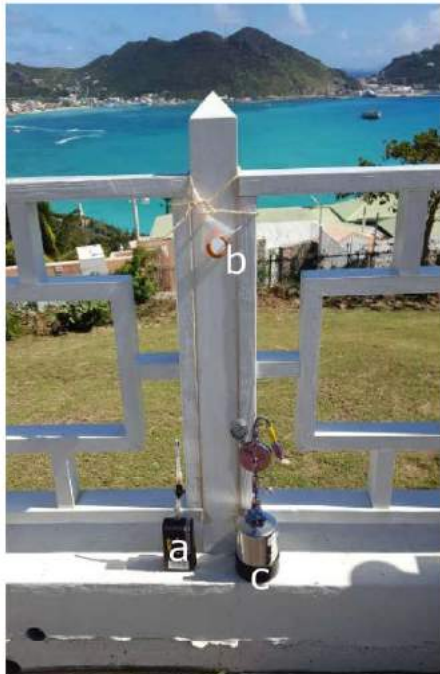
Figure 10 Pump (a) with charcoal tube, 3M™-badge (b) for passive sampling and metal canister with restrictor (c) for a sampling time of  $\pm 2$  hours at Belair (location C).

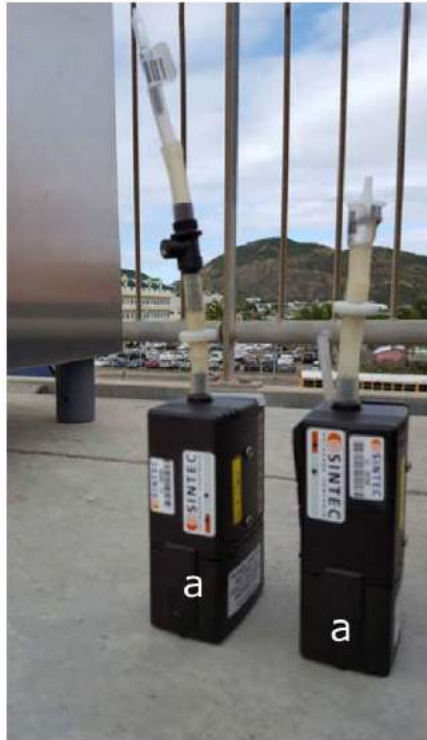
Figure 11 Pumps with active carbon tube (a) and aldehyde cartridge (b)

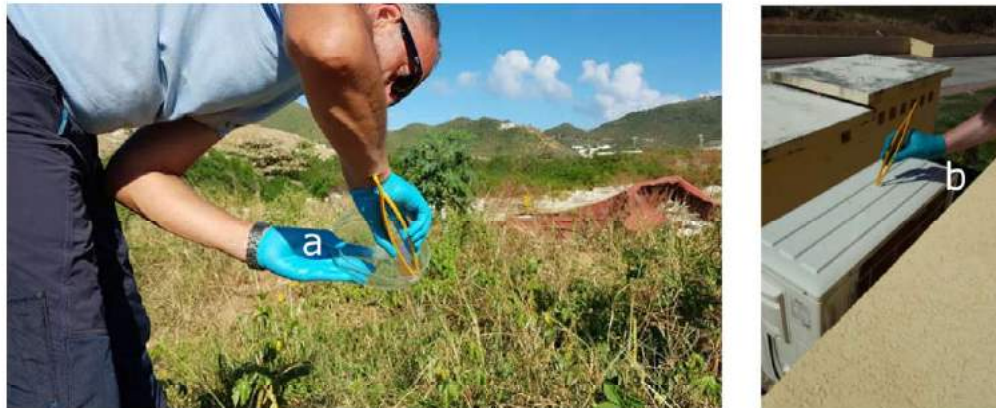
Figure 12 Dust sampling: wiping a Petri dish (a) and a 'historical wipe' (b).

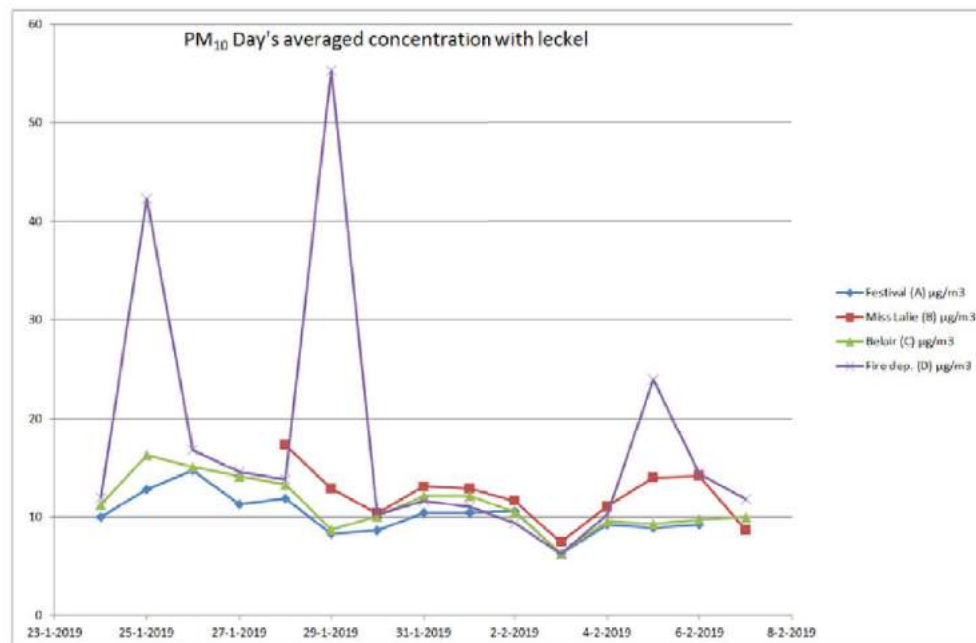
Figure 14 Chart of daily average concentration for particulate matter (PM<sub>10</sub>)

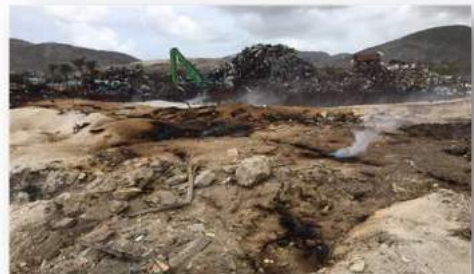
### Surface and subsurface fires occurring on landfill and Irma debris site

- Surface fires extinguished but smoke still observed on both
- Extent of fire below surfaces unknown
- Fires below surfaces and smoke likely will continue until extinguished
- New fires remain a concern – Improved landfill management is KEY

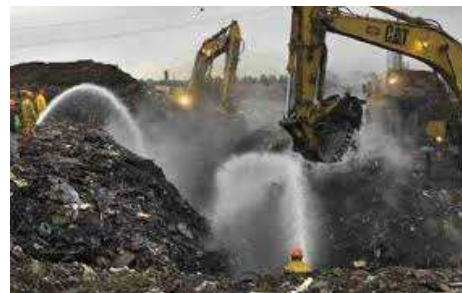
### Fire Suppression Activity

- Extinguish burning waste, may use multiple approaches
  - Water
  - Foam
  - Grout
  - Oxygen starvation

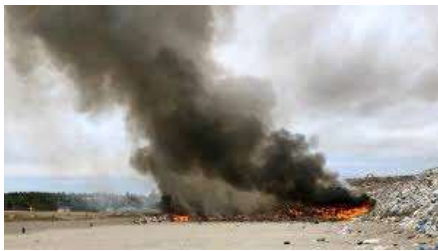
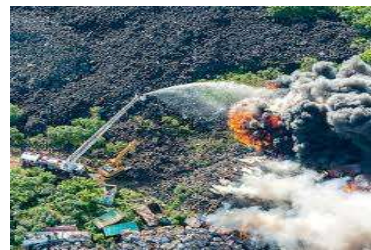
### Possible Fire Suppression Activities

- Excavation/quenching of smoldering wastes may be necessary
- Smoke/dust emissions control a priority – some approaches result in more or different emissions than others

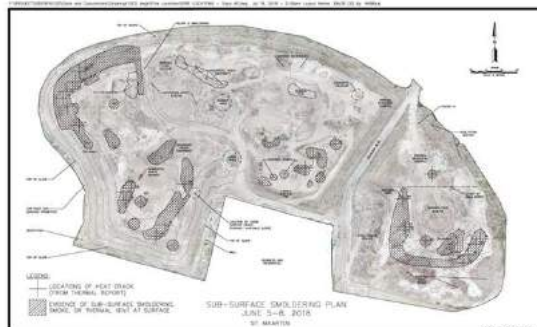
### Fire suppression mitigation measures

- Air monitoring will be performed at boundaries of work zones
- Work will be stopped if air monitoring demonstrates risk offsite or wind direction warrants

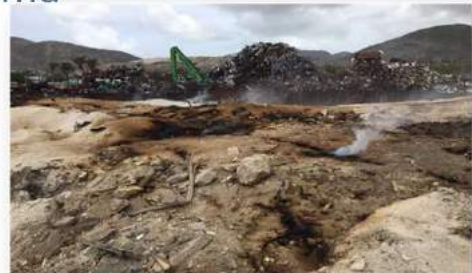
### Fuegos superficiales y subterráneos ocurren en relleno sanitario y en el sitio de desechos de Irma

- Fuente de los Fuegos – Combustión interna o fuente externa.
- Los Fuegos superficiales han sido extinguidos pero aún se observa humo en ambos.
- Se desconoce la expansión de fuegos subterráneos.
- Los fuegos subterráneos y el humo probablemente continuarán hasta que estos sean extinguidos.

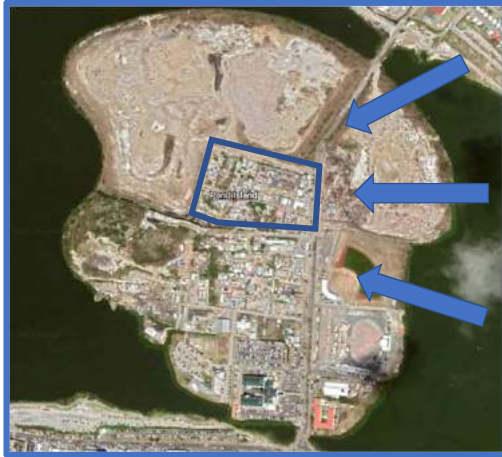
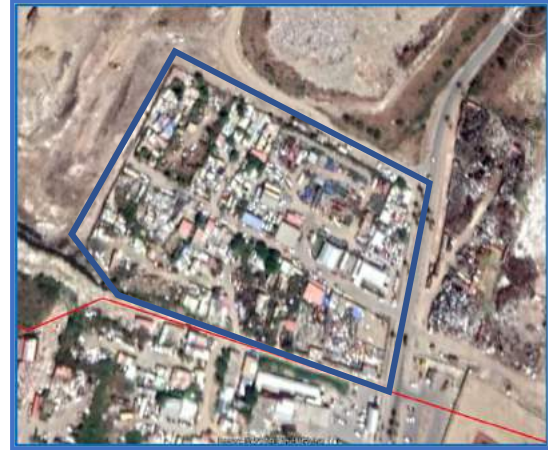
## ZONA PRELIMINAR PARA SER EVACUADA

Vientos prevalente del Este
